Using Street View to Audit the Built Environment

Is it Reliable?

Cheryl Kelly, PhD

Jeff Wilson, PhD

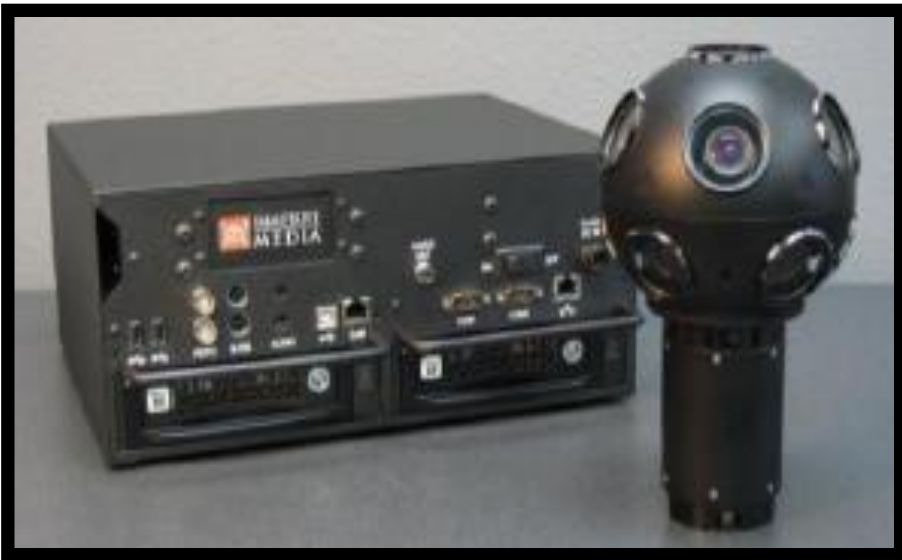
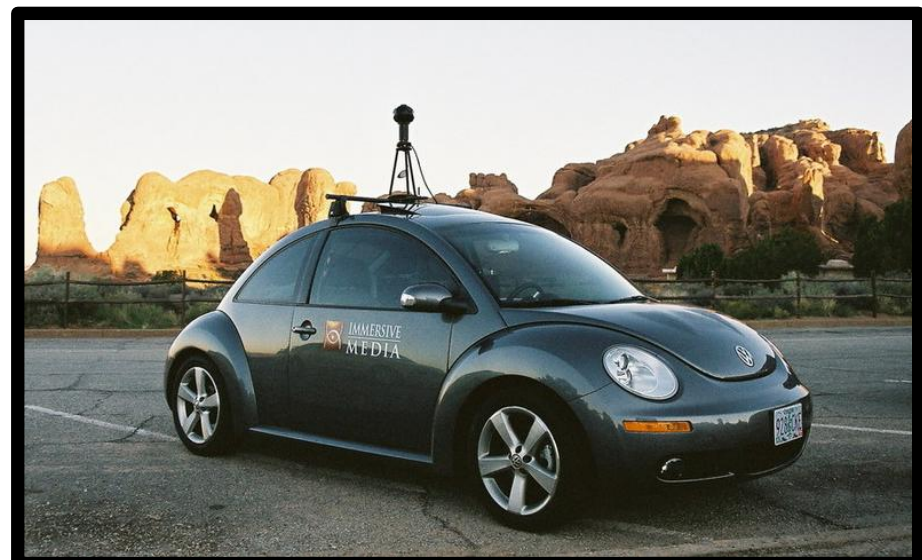
- Omnidirectional Imagery
 - Simultaneous collection of images in multiple directions from a single location producing a panoramic view
 - Allows the viewer to virtually walk or drive through a community to observe characteristics
 - Imagery provides a visual record of built environment characteristics (potential for retrospective studies)

- Example of an omnidirectional imaging system
